Manhole Inspection Summary

Manhole # S29WW_024MH

Insp Date: **5/16/07 9:47 AM**

Location Address: **728 FIELD ST**

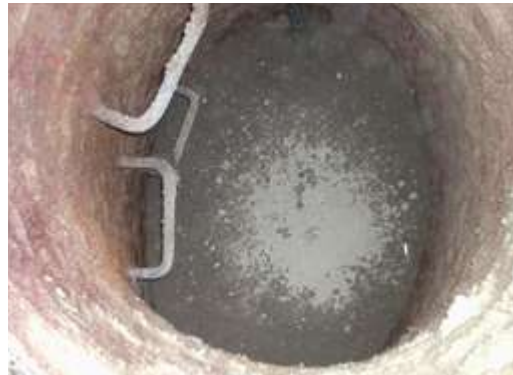
Top View

☒ **Debris** (not Condition related)

Channel debris.

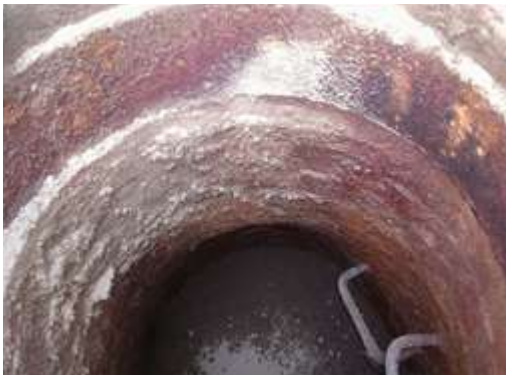
Defect

☒ **Leaks**

Infiltration: ☐ None ☒ **Joint** ☐ Cracks ☐ Mortar ☐ Roots ☒ **Wall**

Frame leaks. Adjustment infiltration - other side.

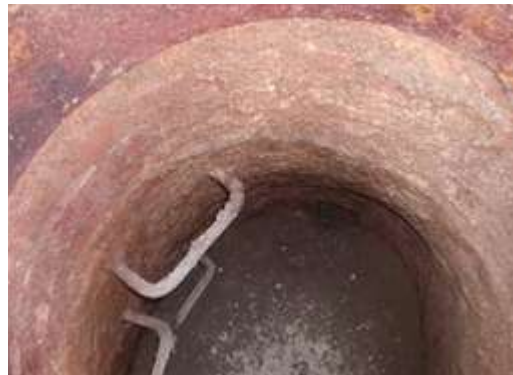
Defect

Frame leaks. Adjustment infiltration.
